# Manhole Inspection Summary

Manhole # S43E2\_004MH

Insp Date: **12/20/07 12:22 PM**

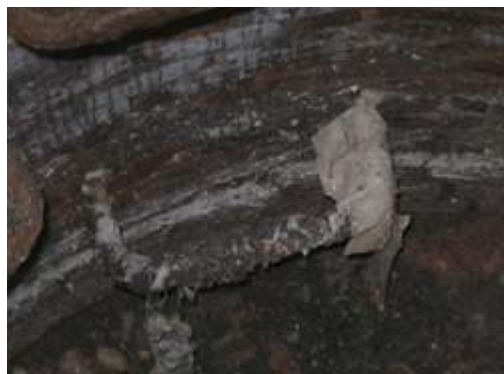
Defect 2

**Surcharge** ☒ **Evidence Of Surcharge** Depth: **1.5** (ft.) ☐ Active Surcharge Present

Surcharge

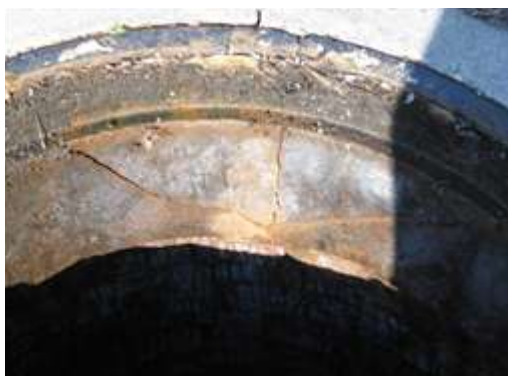
Defect 1

**Frame** Offset: **0** (in.) Condition: ☐ Sound ☒ **Cracked** ☐ Leaks

Cracked frame

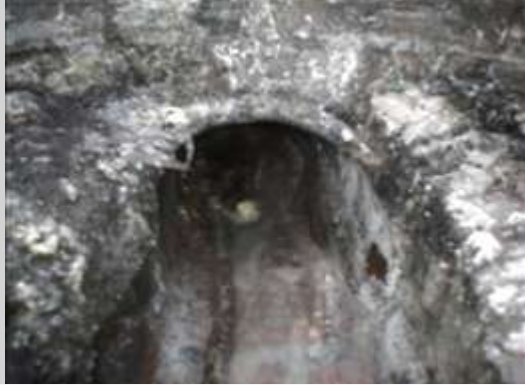
12 O'Clock Outflow

8 in. Circular Gravity Sewer  
Pipe Out @ 12 O'Clock

Pipe Height: **9.6** (in.) Rod and Bar (Angled)  
Pipe Material: **Clay** ☐ Pipe Lined  
Invert Depth: **7.87** (ft.) Flow Characteristics: **Fast**  
Deposits: ☒ None ☐ Mud ☐ Sludge ☐ Debris ☐ Grease  
Silt Depth: (in.) Deposits Extent:  
Infiltration: **None** Pipe Seal Cond: **Sound**

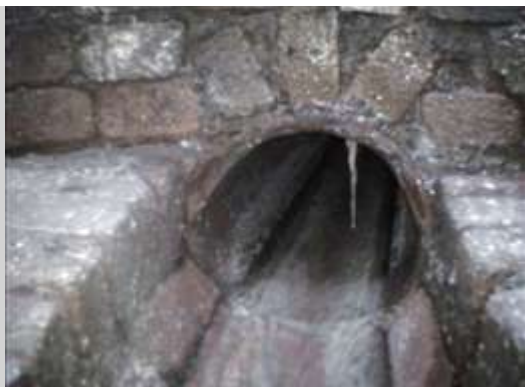
7 O'Clock Inflow

8 in. Circular Gravity Sewer  
Pipe In @ 7 O'Clock

Pipe Height: **10.8** (in.) Rod and Bar (Angled)  
Pipe Material: **Clay** ☐ Pipe Lined  
Invert Depth: **8.26** (ft.) Flow Characteristics: **Fast**  
Deposits: ☒ None ☐ Mud ☐ Sludge ☐ Debris ☐ Grease  
Silt Depth: (in.) Deposits Extent:  
Infiltration: **None** Pipe Seal Cond: **Sound**
